Trouble-Shooting in a Natural Gas Compressor Plant

Inadmissibly high vibrations had occurred in the main pipelines between the discharge-side pulsation damping of a newly installed natural-gas compressor. A duly conducted measurement analysis of the reason for these vibrations indicated that they were caused by strong pressure-pulsations in the cylinder rooms and in the downstream connection pieces to the pulsation damper vessels. A direct link between these pressure-pulsations and the mechanical vibrations was found in the region of the double-acting cylinders. Also the mechanical natural frequency of the connected pipe leads to inadmissible high amplitudes of vibrations.

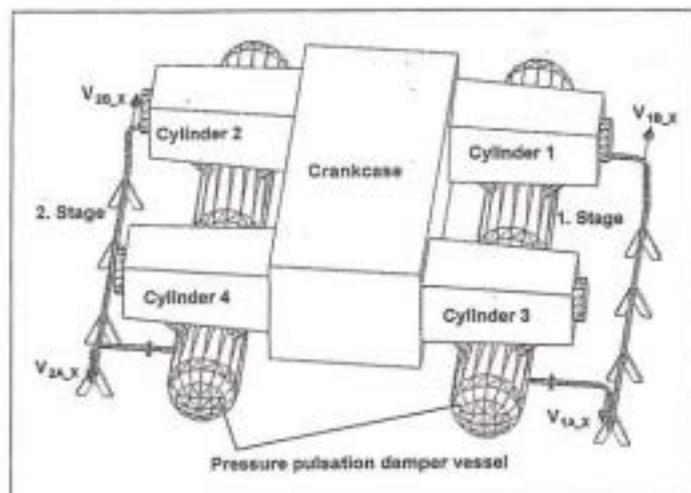
Fig. 1: Schematic diagram of reciprocating compressor, pressure pulsation damper vessels, connection lines, and the four points at which vibrations were measured

The first measurement of vibration rates made at the pipe bends in the modified version of the system shown in Figure 1 exceeded the manufacturer's admissible standard levels several times over.

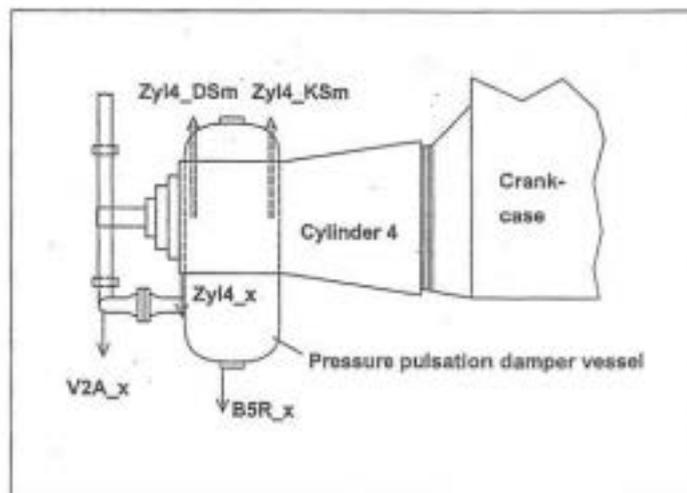
Fig. 2: Position of measurement points for detailed analysis of vibrations at Cylinder 4

Therefore at the same time, pressure pulsations and vibration rates at Cylinder No. 4, at the pressure-pulsation damper vessel connected to it and in the pipe bends were recorded selectively for further analysis (Figure 2).

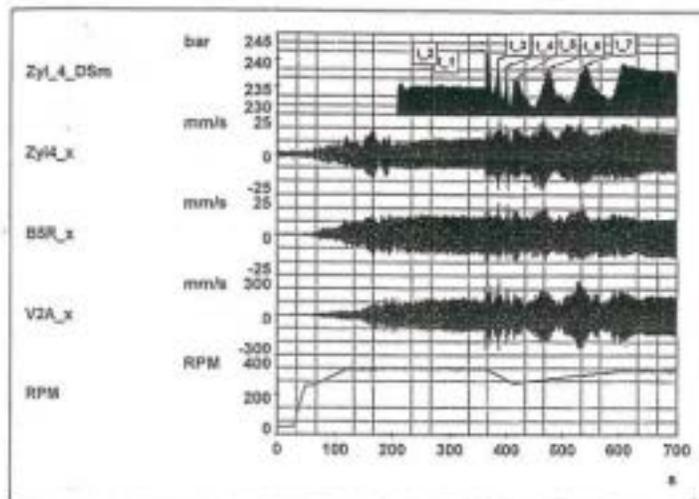
Fig. 3: Simultaneously recorded vibrations and pressure developments at Cylinder 4

Figure 3 shows portions of the signals measured at Cylinder 4 when running up and when operating the compressor plant. The cylinder room (Zyl4_KSm) at the crankshaft end was shut off by controlled valve-suppression when this measurement was taken.

The chart shows the development of cylinder room pressure on the cover side, vibration rates at different measurement points, and rotational speed extending over a period of about 11 minutes from plant start-up. Especially at pipe bend $V_{2A,x}$, there is no recognisable increase in vibration at the measurement points when the plant is being run up ($t = 40 - 60$ s), so the likelihood of vibration being excited solely by the inertia force of the compressor can be ruled out. Once pressure has built up in the cylinder room ($t > 200$ s), however, continuously increased vibrations of about $V_{2A,x} = 100$

mm/s become evident at the pipe-bend measurement point. The compressor is run at its rotational speed in the period $t > 360$ s (other operating conditions remaining constant), this being accompanied by a marked instance of short-time increases (t_1 to t_7) in cylinder-space pressure and in vibration rate at the measurement points shown.

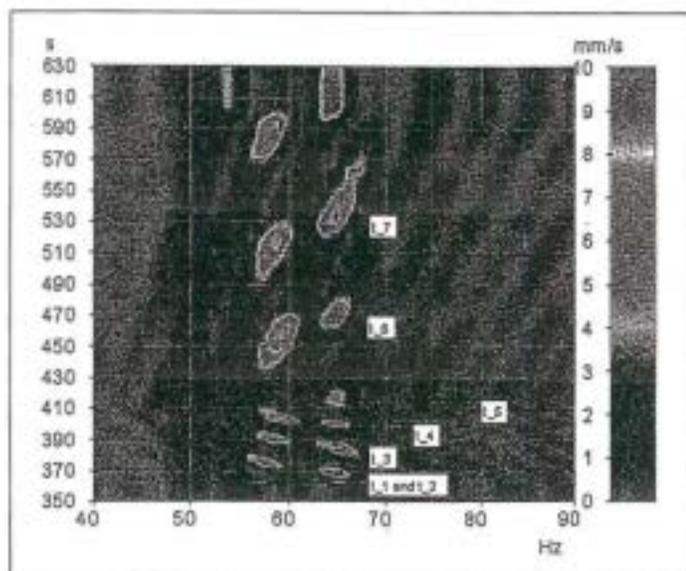
Fig. 4: Colour chart of amplitude spectra for measurement-point Zyl4_x at the cylinder within the time range $t = 350$ to 630 s (time signal from Figure 3) cylinder 4

Colour charts of the amplitude spectra of the vibrations were produced to allow more precise examination of the relationship between the increased pressure fluctuations and the vibrations. To do this, the recorded time-signal was divided into small, overlapping time sections ($\Delta t = 1.6$ s), the amplitude spectrum (FFT) for each section then being duly calculated and represented as colour chart (amplitude level identified by colour) along the time axis. The colour chart in Figure 4 clearly shows that, at

Cylinder 4, two separate amplitude increases (58 Hz; 63 Hz) occur at different times along the x axis. Comparing the times of the maximum increases in cylinder room pressure in the function envelopes in Figure 3, the 63 Hz amplitude increase is the only one occurring at the same time in each case (Figure 4). While the order of magnitude of the vibration rates measured at the cylinder is not a cause for concern, those at the pipe bend (measurement point $V_{2A,x}$) are inadmissibly high, especially the 63 Hz recording (Figure 5).

There is a striking increase in vibration between cylinder and pipe-bend (compare scale of Figure 4 and Figure 5).

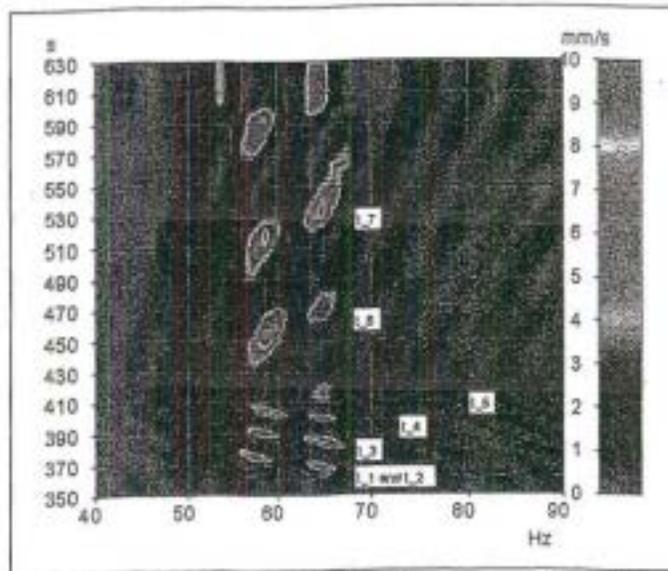
Fig. 5: Colour chart of amplitude spectra for measurement-point $V_{2A,x}$ at the pipe bend within the time range $t = 350 - 630$ s (time signal from Figure 3)

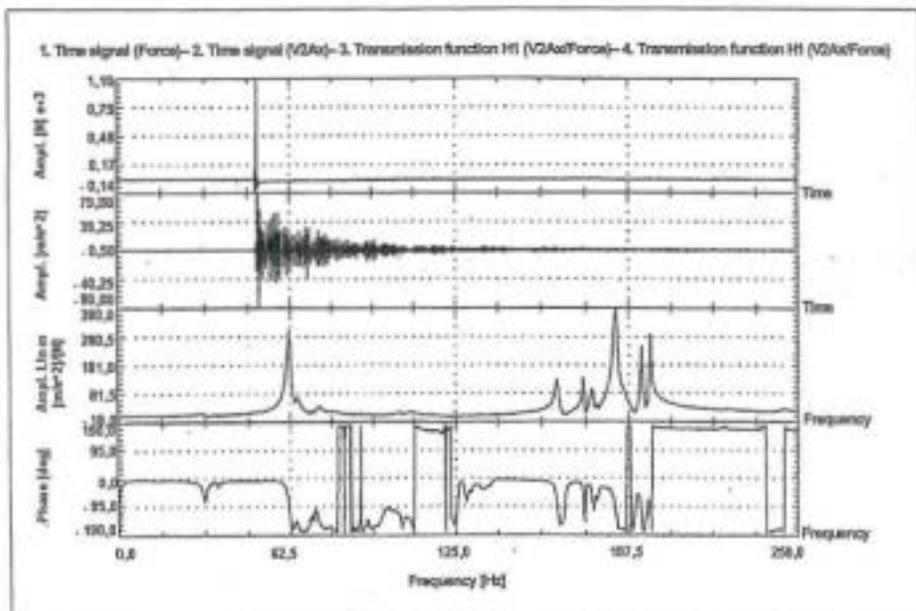
Fig. 6: Transfer function of acceleration signals of a force impulse excitation at the pipe-bend

Excitation was produced by means of an impulse hammer at measurement-point $V_{2A,x}$ at which the acceleration response was also recorded along the x axis in each case. An amplitude increase occurs at about 62 Hz, accompanied by a 180° phase-shift between excitation and response signal. Accordingly, the increase in operational vibration between cylinder and pipe-bend is caused by a mechanical natural frequency, thus disclosing the transmission path of vibrations emanating from the cylinder. To ascertain the cause of the cylinder vibrations, the measured development in cylinder room pressure from Figure 3 at the maximum point ($t_2 = 368.2$ s) and at the succeeding minimum ($t_2^* = 375.6$ s) are plotted over time in Figure 4.

To arrive at an explanation of this increase in amplitude, the natural frequency of the pipe bend was analysed with the compressor plant at a standstill (Figure 6).

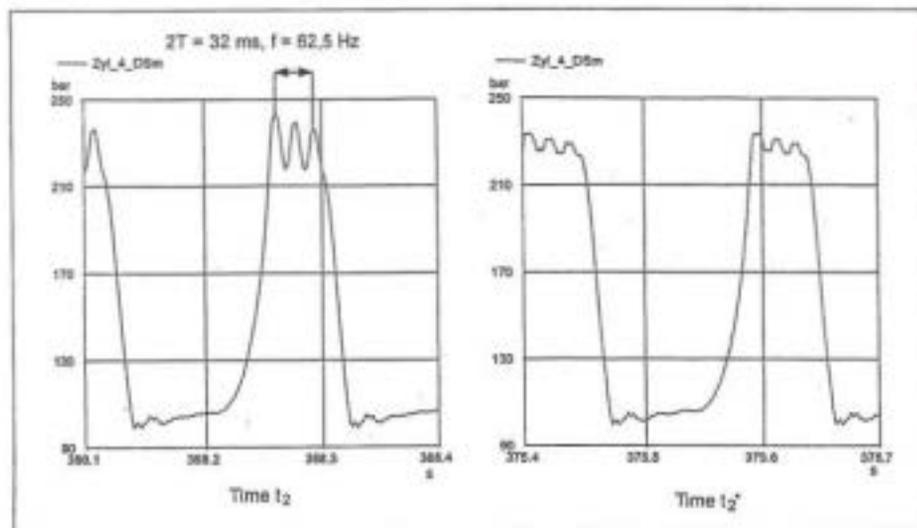
Fig. 7: Measured pressure pulsations at 330 rpm (t_1) and 300 rpm (t_2)

Pressure pulsations of up to 25 bar peak-to-peak (depending on rotational speed) occur at a frequency of $f = 62.5$ Hz in the process of exhausting the natural gas (Figure 7). These pulsations are the actual cause of the increased vibrations, which are transmitted mechanically from the cylinder, through the pulsation damper vessel, to the pipeline. The pulsation is excited by an acoustic natural frequency in the intermediate pipe (the connection between cylinder and pressure pulsation damper vessel) when it coincides with higher-harmonic frequencies of the rotational speed. The same effect was also found to exist in the other cylinders of the compressor.

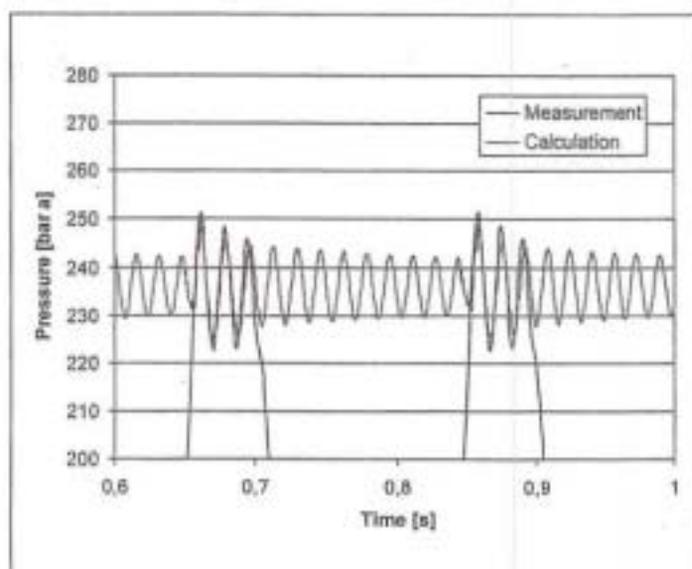
Fig. 8: Measured indicator diagram and calculated pressure inside the connecting pipe in original state

To begin with, the original system including its orifice plates was modelled for the purpose of validation. Figure 8 illustrates the measured indicator diagram together with the calculated, time depending pressure at the discharge-side cylinder flange.

It can clearly be seen that each time the pressure valve is opened (accompanied by the associated, abruptly beginning mass flow), a feebly dampened acoustic natural frequency is excited in the cylinder room and in the connection pipe. This acoustic resonance is responsible both for the increased strain on the drive unit and for the inadmissibly high pipe vibrations. The amplitude of the gas vibration is very decisively determined here by favourable or unfavourable coincidence between the opening of the valve and the phase angle of the acoustic resonance (see Figure 7).

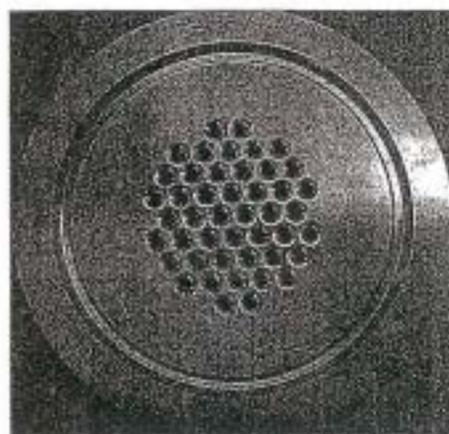
Fig. 9: Gas inlet side of patented "pulsation damper plate based on the KÖTTER principle" fitted to cylinder output flange of second stage

The pulsation damper plate (Figure 9) was then incorporated into the design model as the second stage of the simulation.

the plate), the pulsation damper plate offers a great many adjustment options. Apart from providing a choice of number of bore holes, hole pattern and bore-hole diameters, the venturi-like openings of this plate can be formed "at will", so the pulsation damper plate permits optimisation of acoustic or flow-conducting characteristics without additional loss of pressure.

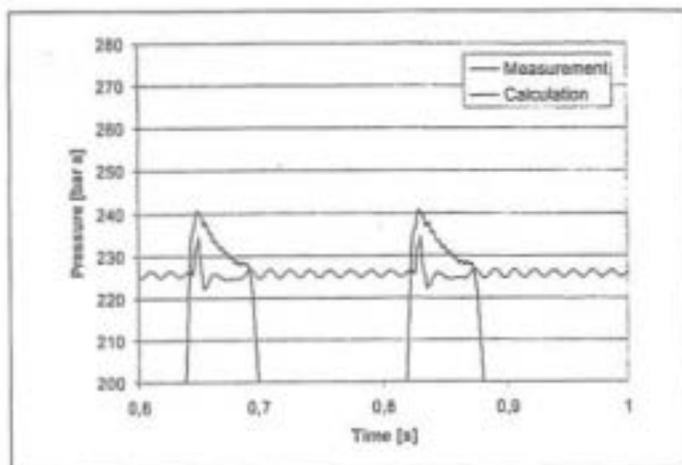
Fig. 10: Measured indicator diagram and calculated pressure inside the connecting pipe with pulsation damper plate installed

Figure 10 illustrates the outcome of this design process with the calculated time depending pressure at the discharge-side cylinder flange with pulsation damper plates installed. The measured indicator diagram after implementation of the modification is included in the figure for comparison purposes.

The theoretically ascertained satisfactory effect of the pulsation damper plates is confirmed by subsequent measurement. There are no more significant gas vibrations to be found in the indicator diagram either. The above-mentioned additional strain placed on the drive unit by alternating pressure loads on the piston has been eliminated by this means, and the alternating pressure amplitudes in the connection pieces have also been distinctly reduced.

However, it can still be seen that the measures adopted have only slightly increased the degree of acoustic damping provided when the pressure valve is closed. The reason for this is the predetermined installation position of the pulsation damper plate.

The only usable flange was located directly at the cylinder, which means that the pulsation damper plate is sited at the acoustically closed end when the pressure valve is closed.

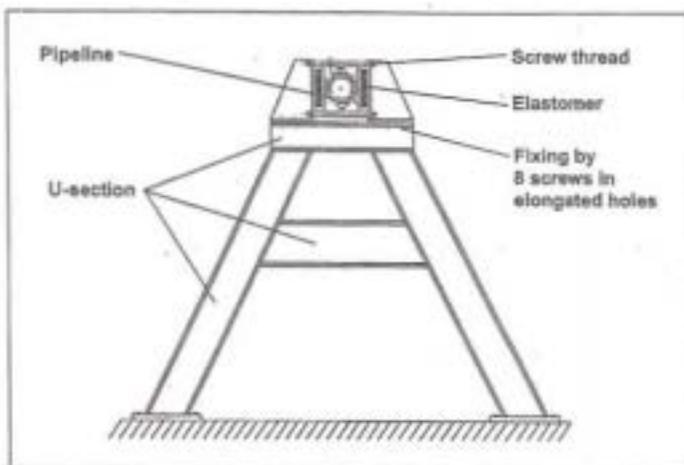
Fig. 11: Additional 'A' support as modification of pipeline section

Furthermore, to make sure that the critical vibrations would no longer be excited by the pulsations still present in the connection pieces, the natural bending frequency of the pipe bends and pipe sections was displaced to a higher frequency (> 70 Hz) by means of an additional 'A' support, and broadband damping was incorporated. Because of the high temperature of the gas and the pipeline, a special means of connecting the support (Figure 11) was chosen for the region of the pipe bend (at the positions of the measurement points in Figure 1).

The elastomer coating shown in Figure 11 is arranged without direct structure-borne noise bridges in such a way that the actual surface pressure of the elastomer (a decisive dynamic parameter) can be adjusted and optimised in situ by altering the tightening torque of the four bolts. Compared with conventional elastomer inserts, which are inserted directly between pipe and pipe clamp, the heat convection inherent in this design tolerates higher temperatures at the outside of the pipe.

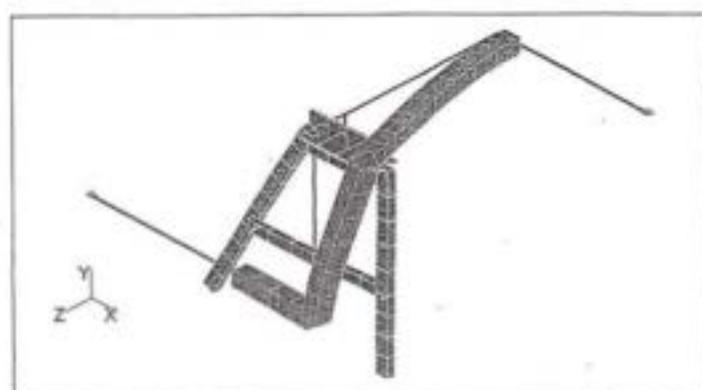
Fig. 12: FE model with 'A' support and elastomer, first natural bending frequency 79.4 Hz

Figure 12 shows the calculated mode of the first bend in the pipeline with the optimised 'A' support and the elastomer

connection. Then the natural frequency is displaced upwards by 30 % as a result of this modification. The critical factor determining the position of the first natural bending frequency is the dynamic stiffness or rigidity of the elastomer.

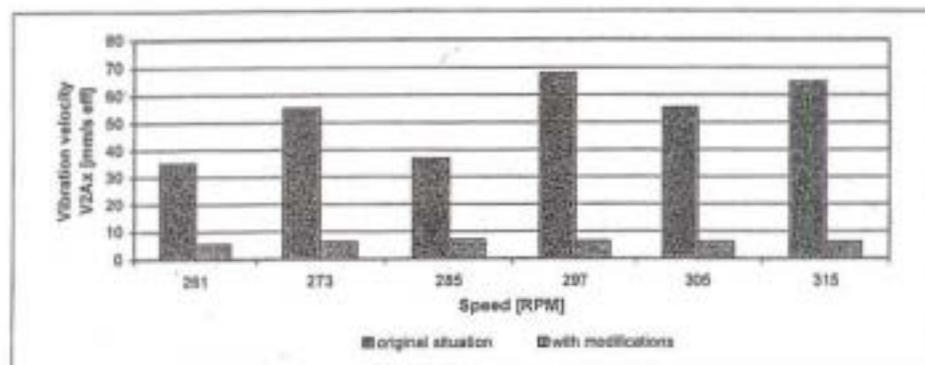
Fig. 13: Measured pipe-bend vibrations in original situation and with modification

Renewed measurement of the natural frequency of the first characteristic bending form or shape indicated a frequency of 83 Hz in the pipeline with 'A' support. In the light of the simplified FE model and the normal deviation of elastomer characteristics from manufacturer's specifications, this indicates good compatibility and confirms the validity of the procedure described above. The results of an additionally conducted measurement of operating vibrations at measurement-point V2Ax in the modified system are shown in Figure 13 for the purpose of comparison with the measured vibrations of the original system.

Comparison of the vibration situation before and after modifications impressively confirms the effectiveness of the measures adopted. A final examination of power loss attributable to the pulsation damper plates also demonstrated the precision employed in designing for pressure loss at the compressor output.
